# Riverwood CDD

## Severn Trent Services Field Management Report Site Inspection – February 03, 2015

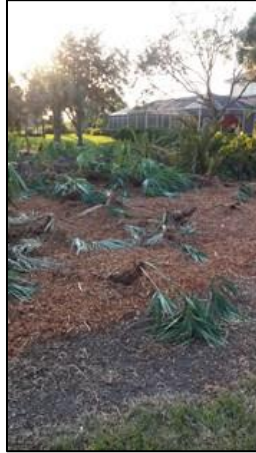
Preserve J (Small Area on the Northeast side) after clearing exotics

- a. Preserve J (East of Bay Ridge) Exotic clearing—mostly Brazilian Pepper.

- After the removal of the Brazilian Pepper (BP), there is a definite visual change. The majority of the area was filled with exotics. However, the beneficial native plants have been left.

- The remaining plants will look puny at first. The reason is because they have been shaded by the Brazilian peppers. The plants will also look crushed or flattened because of the weight of Brazilian pepper (BP), as it was cut and dropped in place, and actually landed, on top of the good vegetation.

- Right now, the plants remaining include saw palmetto and other low growing vegetation. These plants will need a little time to adjust, but they should start looking better and filling in voids now and through the next rainy season. Also, the area has some cabbage palms and a nice oak that will remain.

- The area will be left, as is, through the rainy season to see what adjustments Mother Nature makes, however, the area will also be watched for any exotics that may try to sprout from the seed source or try to migrate into the area, and be treated with herbicide, if necessary.

- Then, after the rainy season is over, we will evaluate the area, and determine if it looks like it lacks plants or has a sparse look to it. If so, we will then determine if we need to add plantings and what type of native plantings should be added to the area.

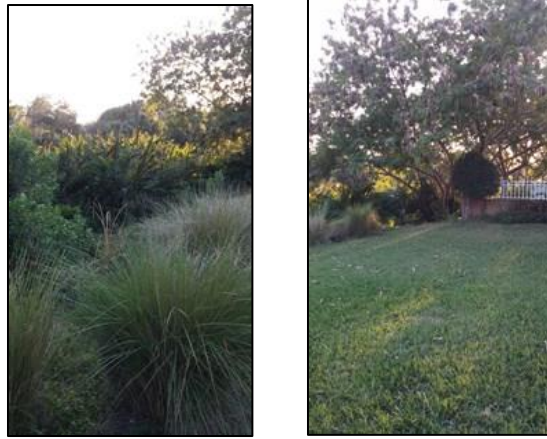
Photos: Tract F & G (Between Bay Ridge and Riverside Neighborhoods)

- b. Tract F & G (Between Bay Ridge and Riverside Neighborhoods). Exotic removal completed. Staging area debris still need to be removed. The canal area within the CDD is now clear of exotics. However, the large Lead Trees that were left are within the Riverside neighborhood. These trees will continue to provide a seed source for the canal area. The Riverside neighborhood should look into removing the trees and replanting area with native trees.

Left: Actual view of the canal after clearing exotic

Right: Remaining Lead Trees

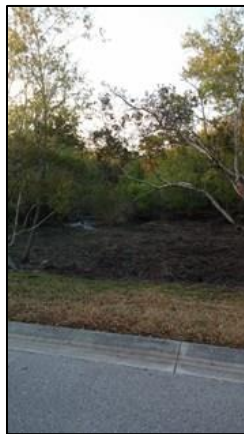
- c. Preserve K (This Preserve is visible along Riverwood Dr. It is actually centered between Village Lakes, Osprey and the Golf Course.) Work efforts cleared exotics and some of the invasive Coastal willow. Residents have commented that they appreciate the work efforts and it looks nice, however, they would like to see additional Coastal willows removed in the future.

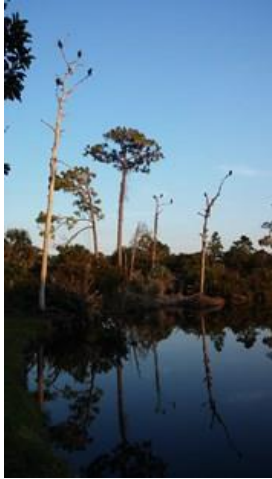
**Preserve P:**

**Photos of Bird Observation**

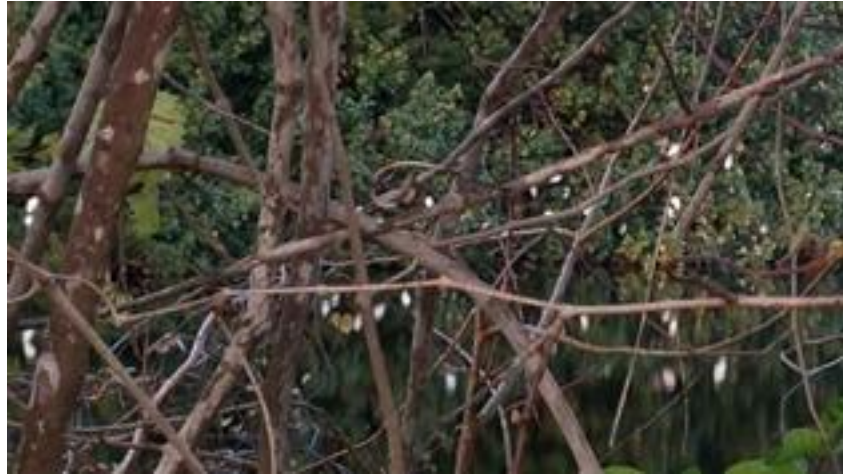
**Rookery**

| <input checked="" type="checkbox"/> Turtle | <input type="checkbox"/> Other Species: Ducks, Anhinga/Cormorant 50 plus, Bird Rookery 150 plus, most likely Ibis, but still need closer visual to identify. | | |
